Replacement Dwelling
Lyndale, Middle Lane,
Cold Hatton TF66QA

Elevations

Drq No 4e

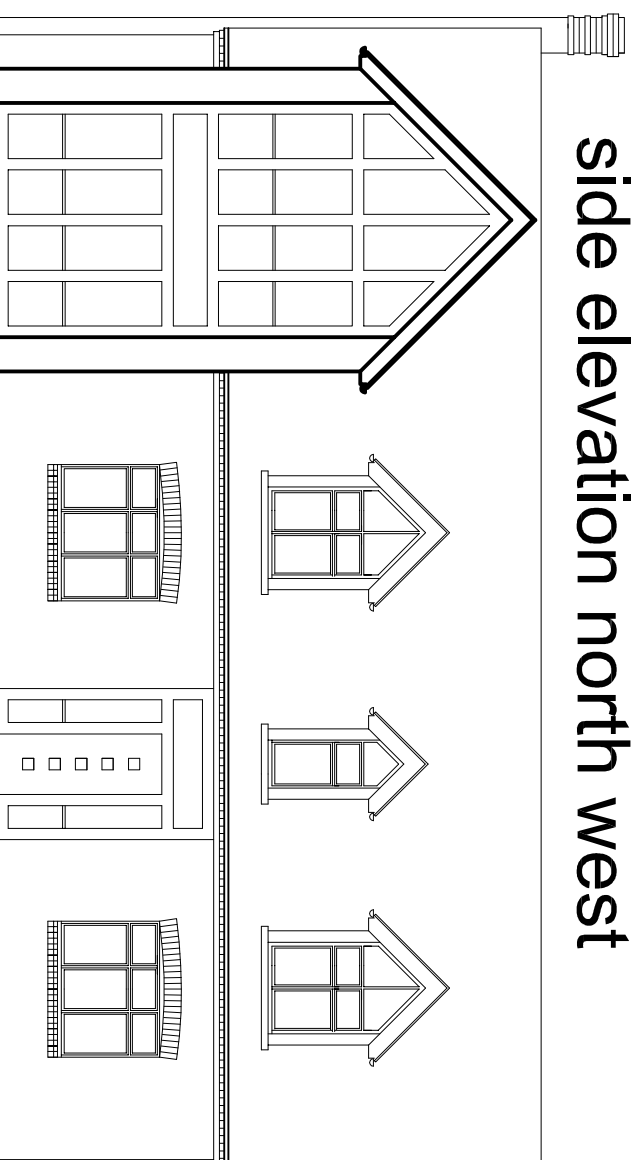
front elevation south west

- External Materials**
- roof-Plain clay tiles
colour to be agreed
 - eaves and verge-
corbelled brickwork
 - gutters and downpipes
coloured seamless metal
 - dormer windows & fascias
coloured upvc
 - external walls-Facing brickwork
to be agreed
 - windows-coloured upvc
Brick arch heads
Brick cills
 - entrance-coloured upvc framing with
coloured upc composite door
feature window front elevation-
oak framed and clad
